Federal Lead Smelter - East Side
LPC# 1190105308/1191155020
Madison County
SF/HRS

CERCLA Expanded Site Inspection

**Federal Lead Smelters (ASARCO)-East Side
Alton, Illinois**

February 11, 2020

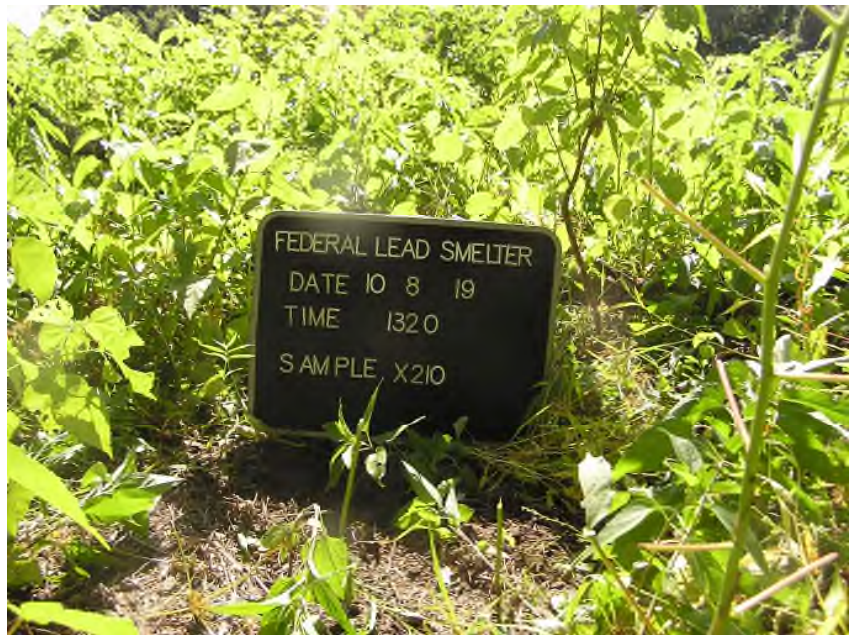
COMMENTS: Sample X210 was collected near the pond. Sample was light brown silt with roots and orange oxidation spots. Area was under water most of the spring and summer.

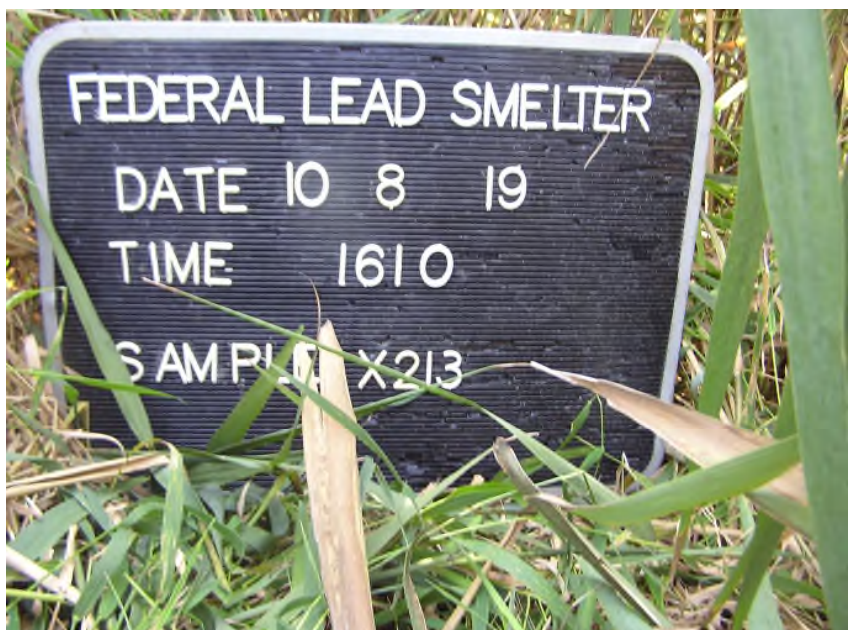
COMMENTS: Sample X213 was collected XRF 58 in the drainage ditch and consisted of medium gray silty clay. Collected from 0-6 inches.

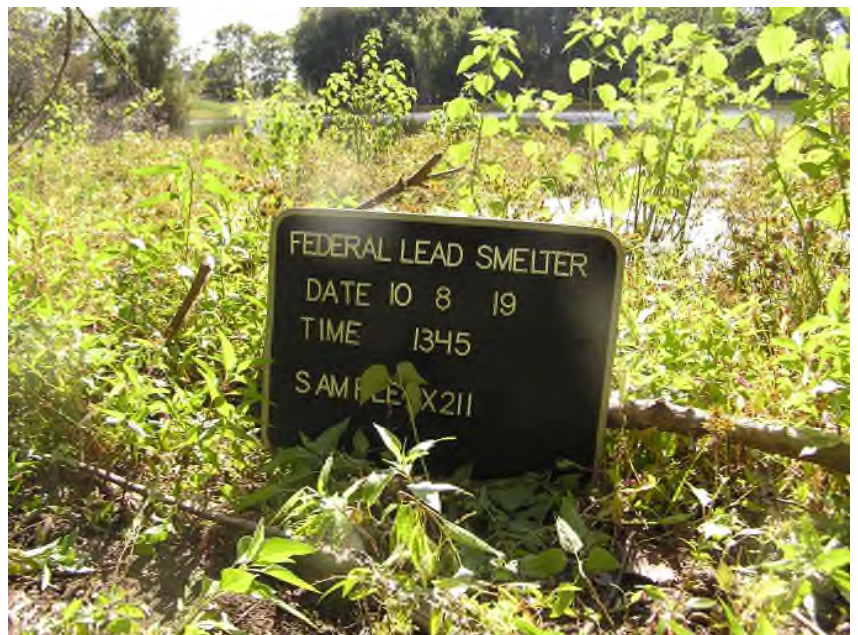
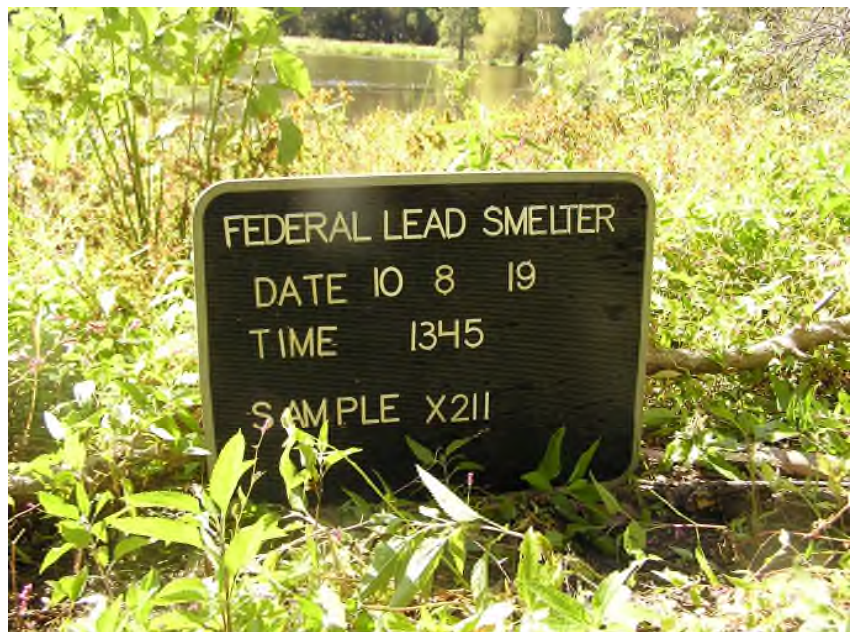
COMMENTS: Sample X211 and was collected from XRF 39 near the pond. Light brown silt with roots. Location was under water for the spring and summer.

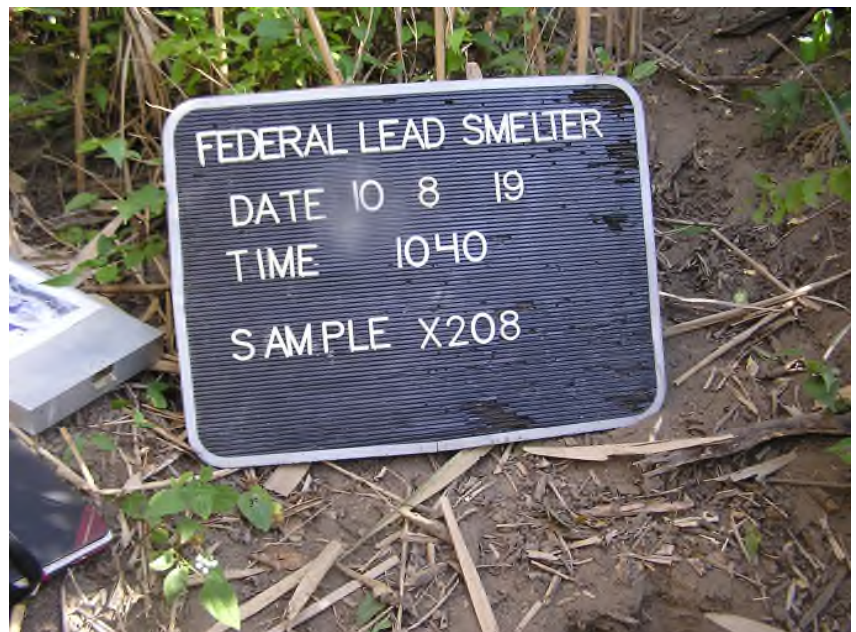
COMMENTS: X208 was collected on side of waste pile in wetland area of intermittent ditch. XRF 6-15 was collected from this location. The material consisted of waste material from the waste pile.

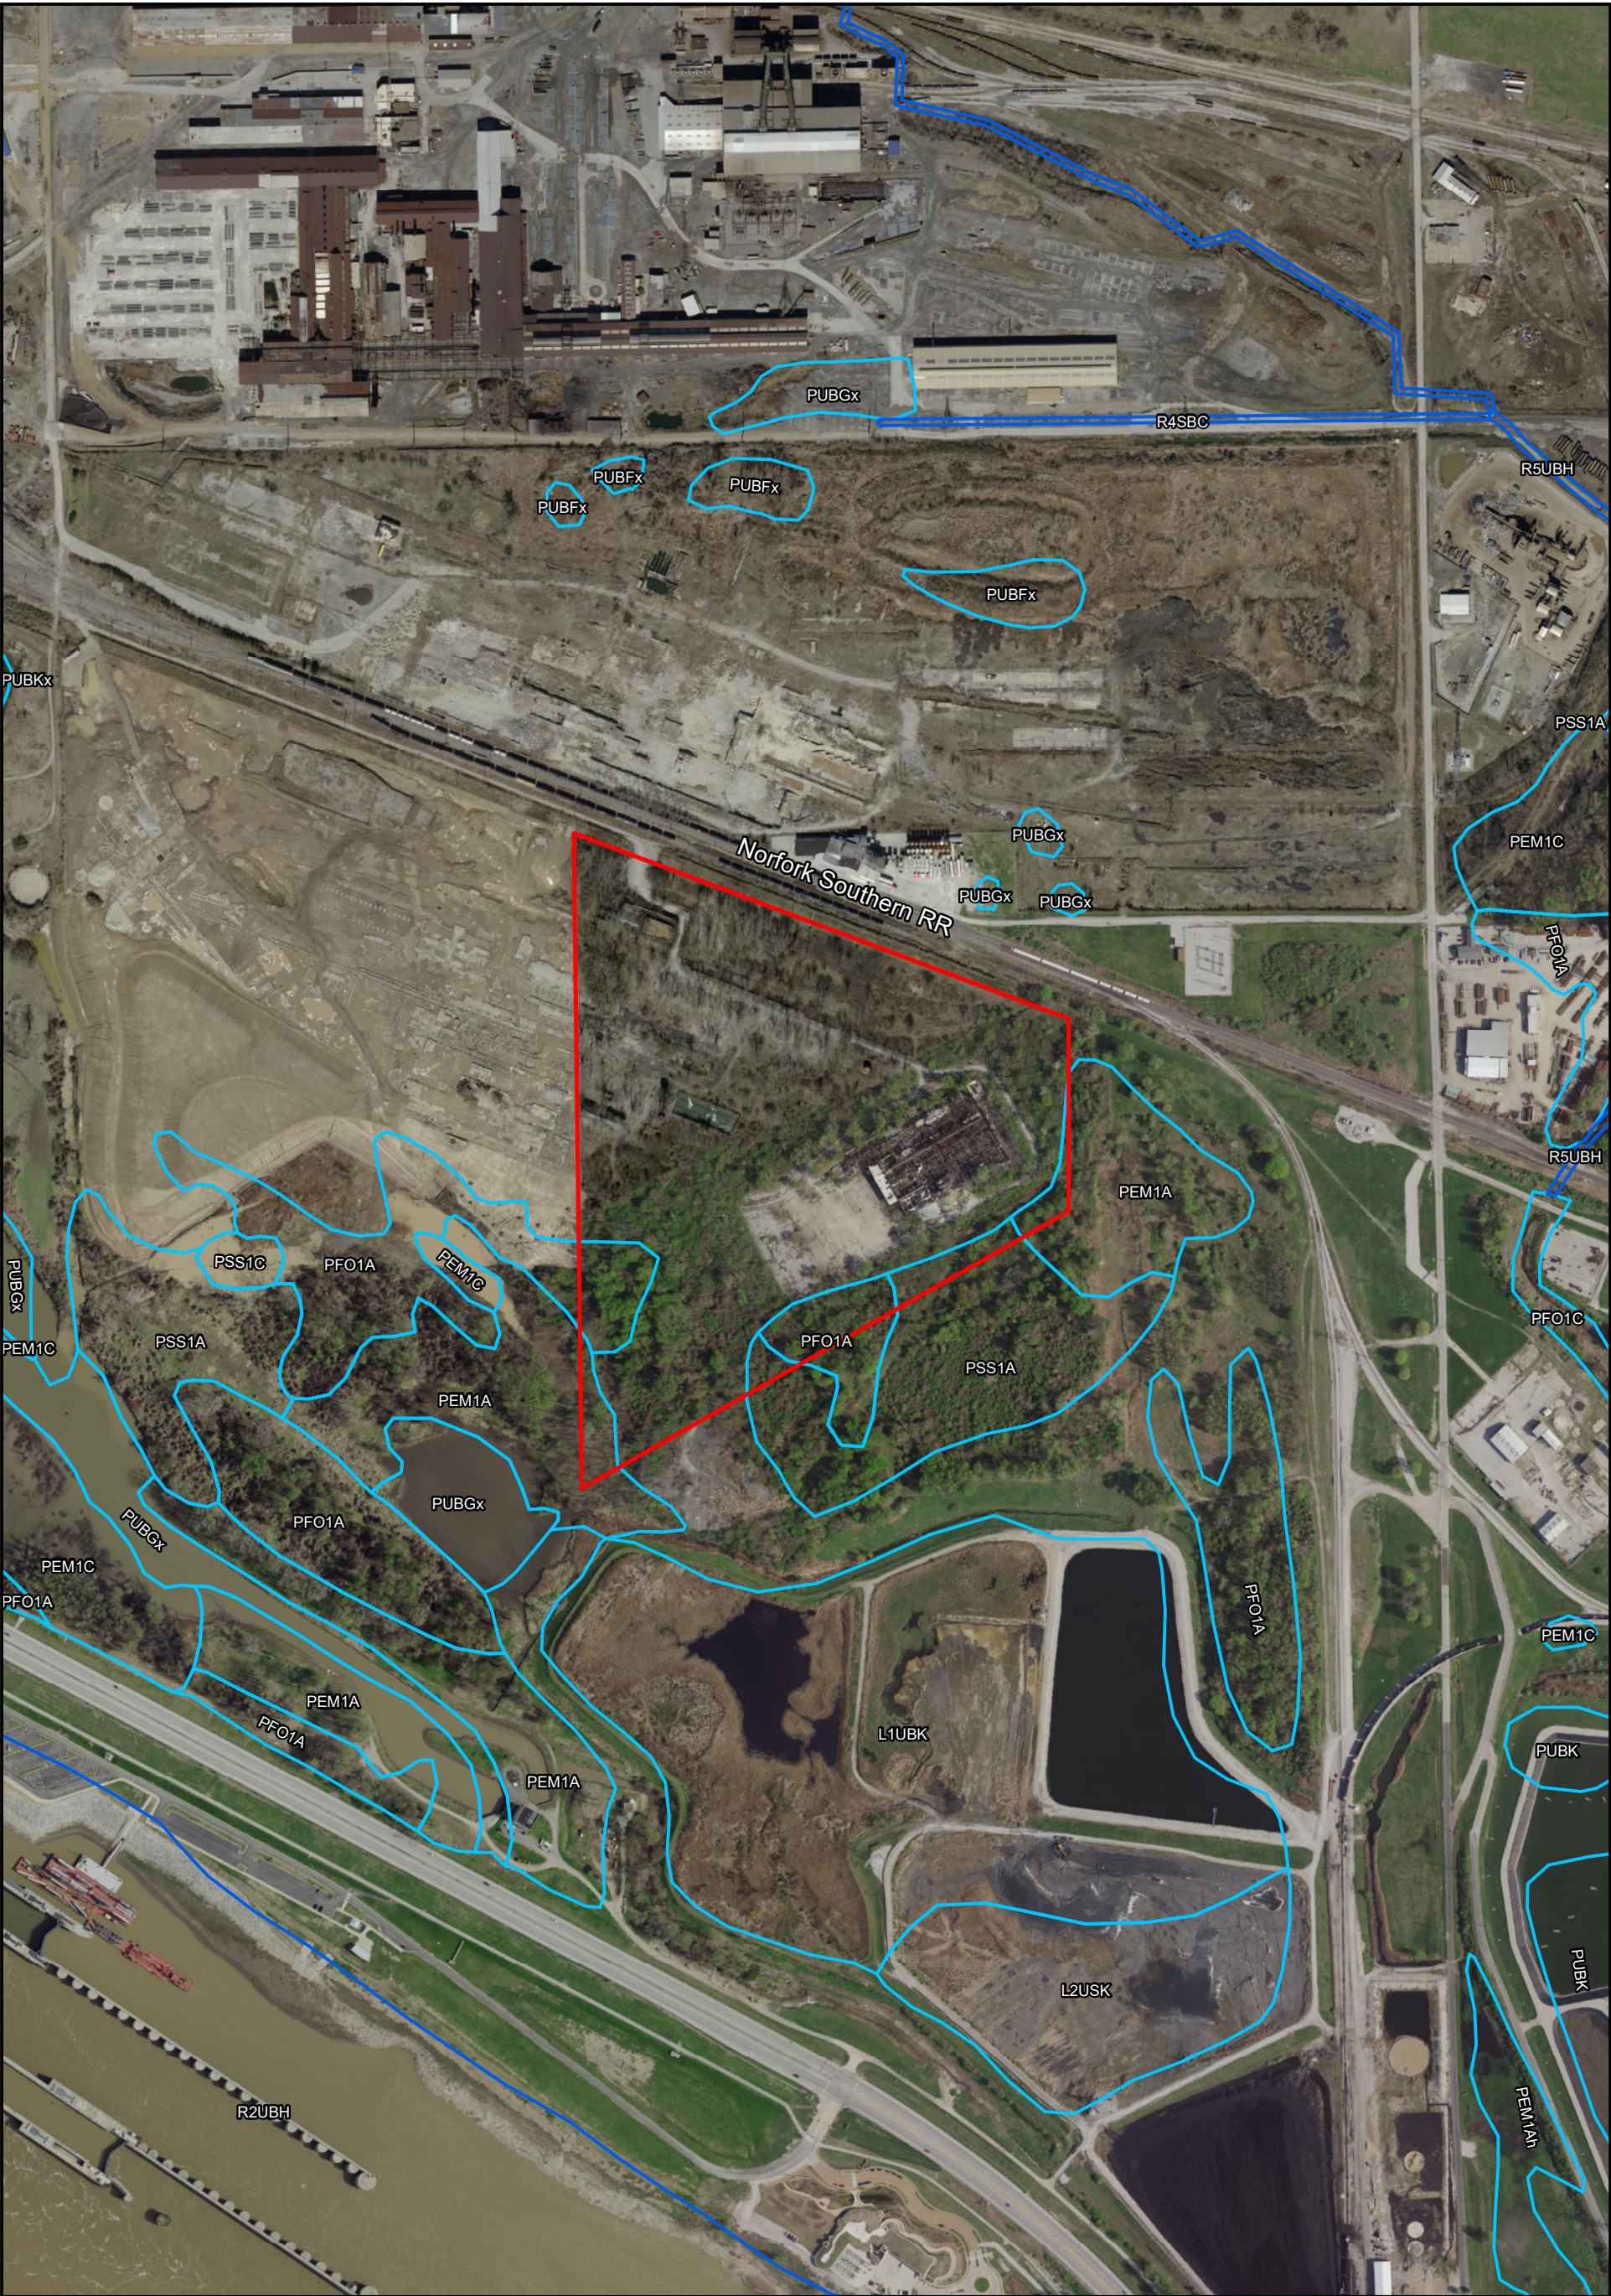
<p>ILLINOIS Illinois Natural History Survey PRAIRIE RESEARCH INSTITUTE</p> <p>INHS/IDOT Wetland Science Program 1816 South Oak Street Champaign, Illinois 61820</p>	<p>Figure 1 Project Location Map Federal Lead Smelter - East Side Madison County</p> <div><div>0 Meters 500</div><div>0 Feet 2,000</div></div> <p>September 2019</p>	
---	--	--

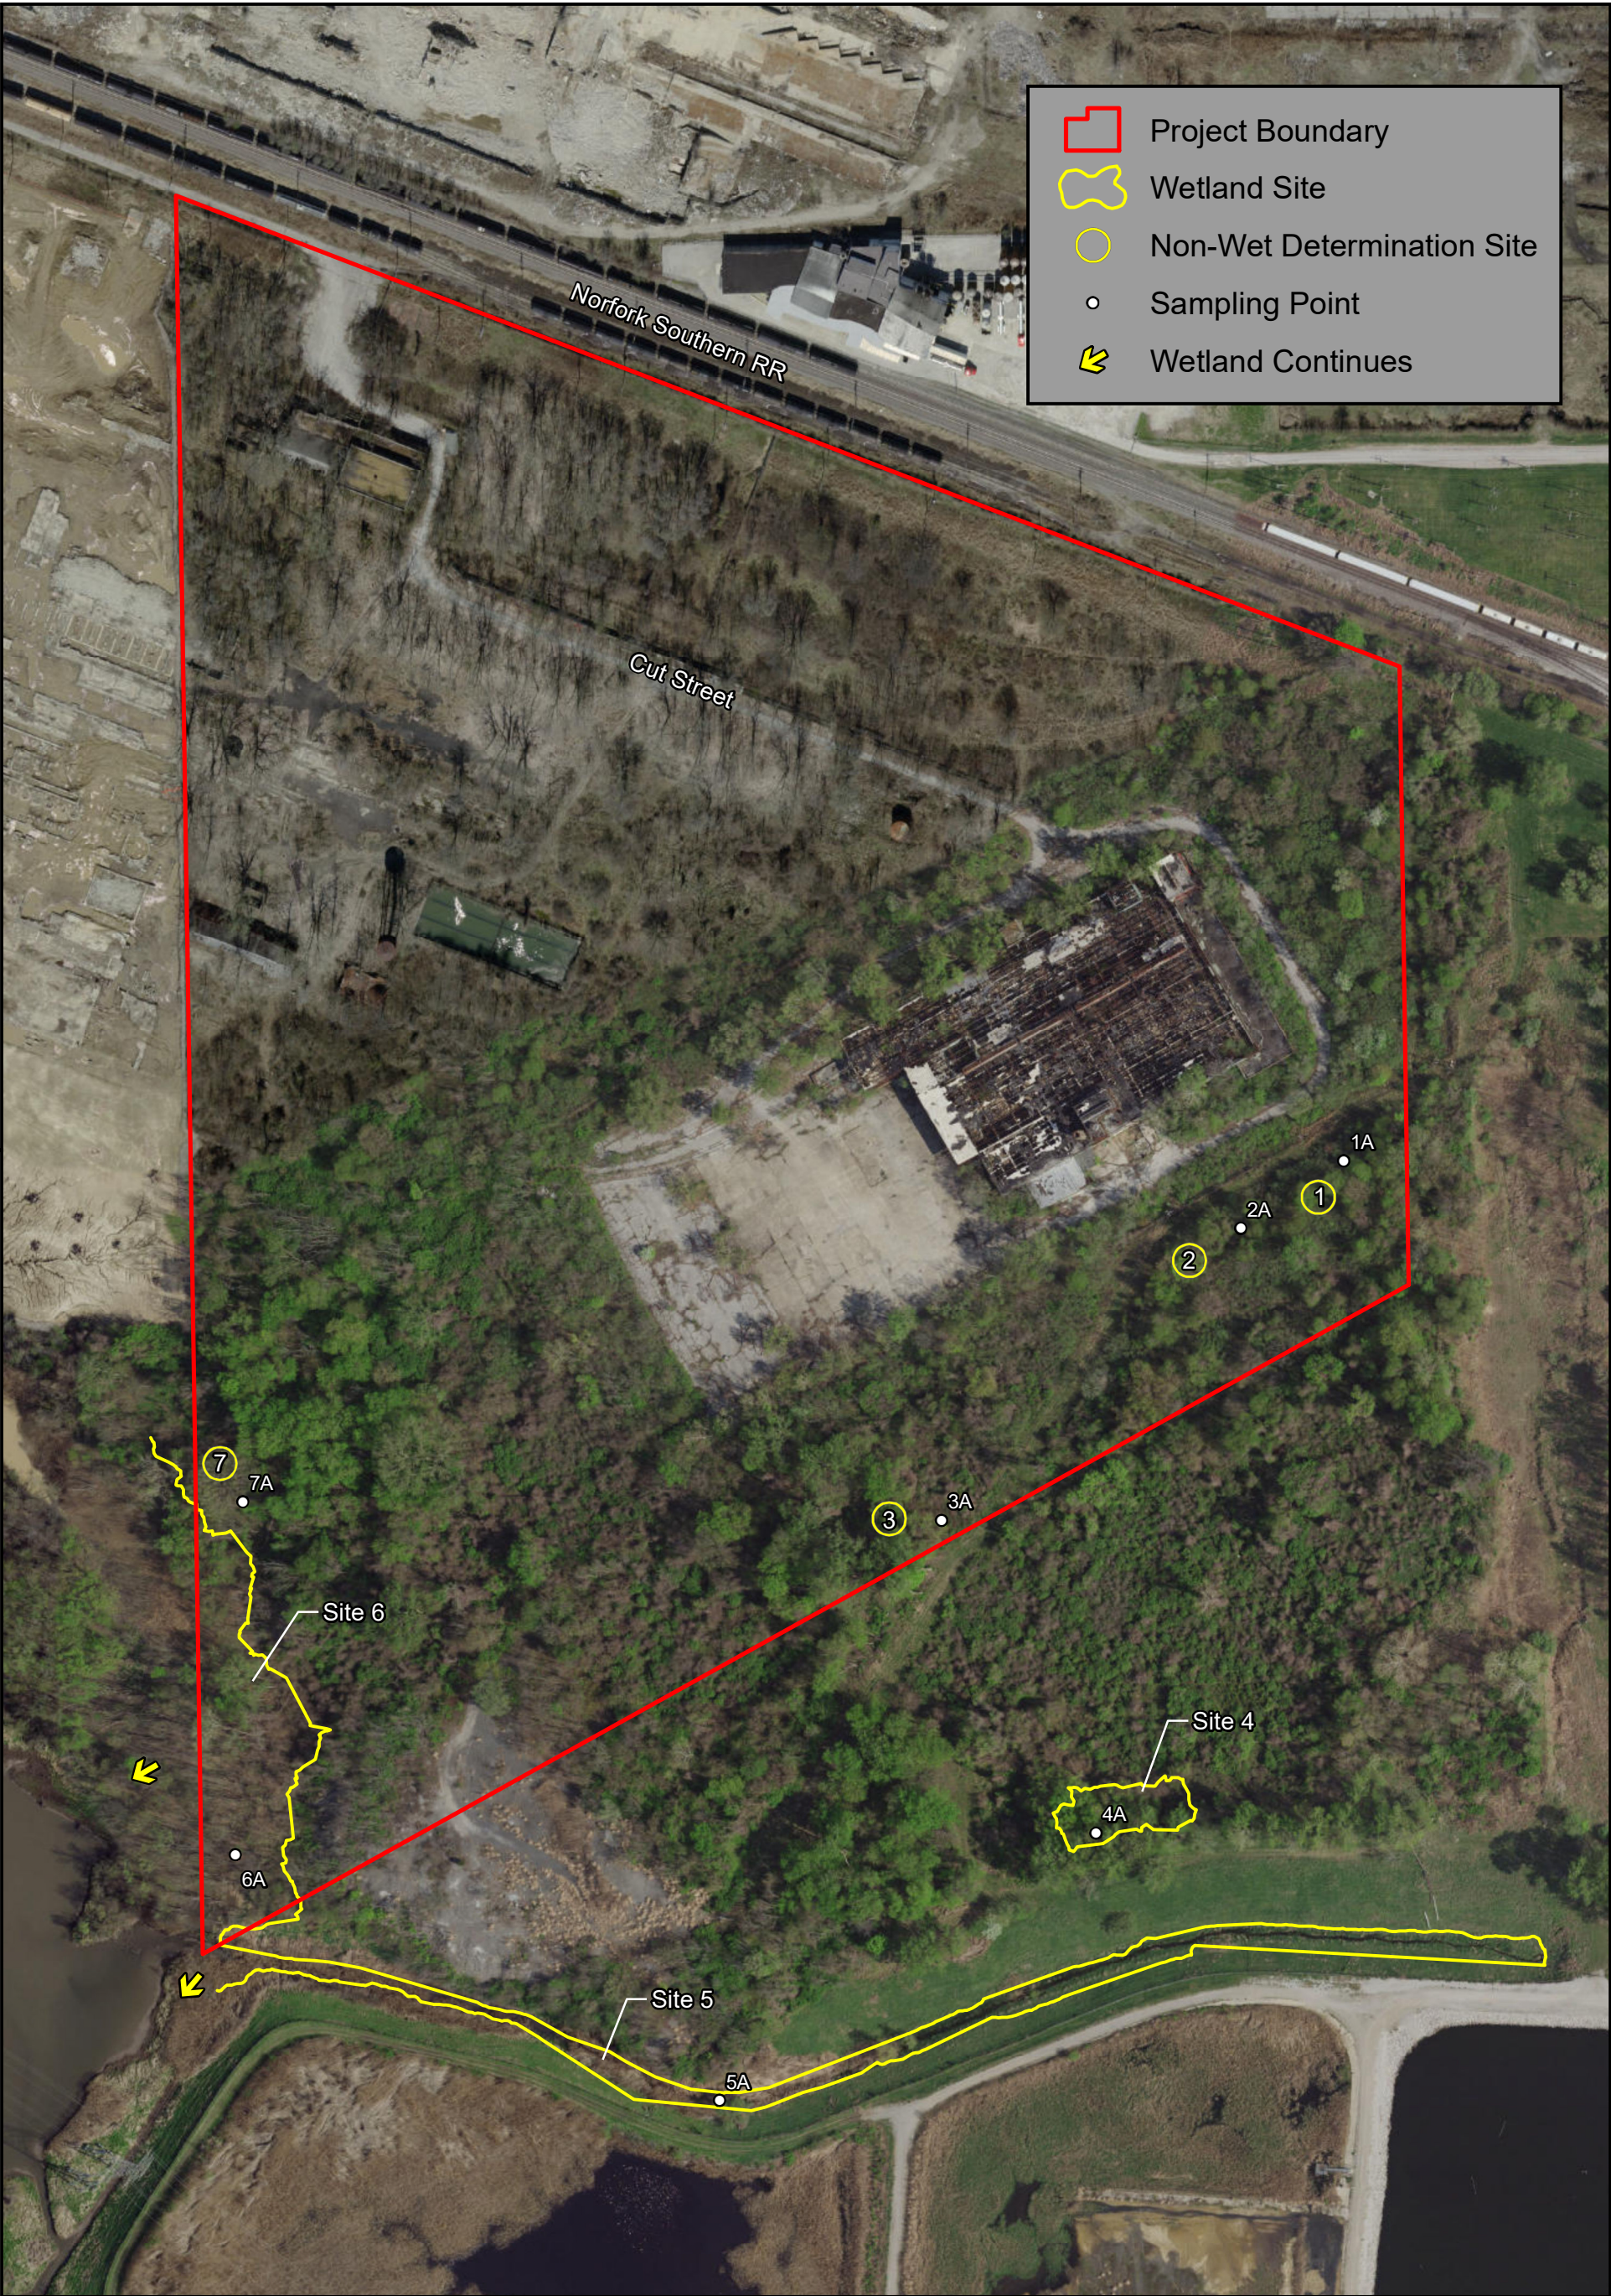
<p>ILLINOIS Illinois Natural History Survey PRAIRIE RESEARCH INSTITUTE</p> <p>INHS/IDOT Wetland Science Program 1816 South Oak Street Champaign, Illinois 61820</p>	<p>Figure 2 National Wetlands Inventory Map Federal Lead Smelter - East Side Madison County</p>		
	<p>0 Meters 100 0 Feet 500</p>	<p>September 2019</p>
